FX 3300-IV: Pump is not working

03/2017, NF

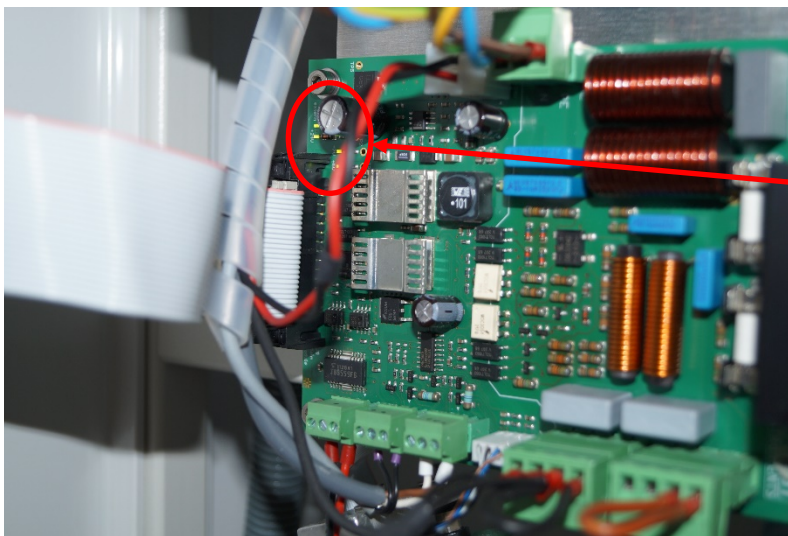
a) Printed circuit board TT 3300-4-920 "Pump control" needs replaced

4 green
LEDs
must be
ON

1. Remove the right and left rear panels from the instrument.
2. Locate the printed circuit board TT 3300-4-920 "Pump control":
3. Switch on the instrument
4. Check, whether or not the green LEDs are ON (4 pcs). If not, please report to Textest which LED is OFF.

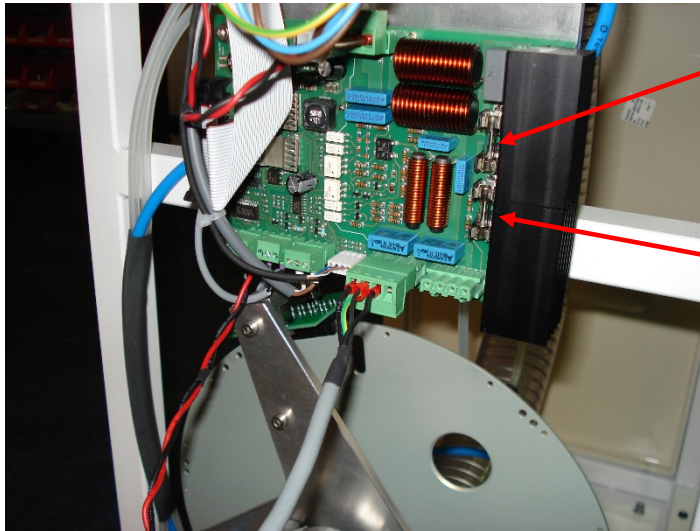
b) The fuse is blown

Fuse for the pump (5 mm size):
- 6 A SB (230 V models)
- 16 A SB (100/115 V models)
(SB = slow blow)

Spare fuse for the pump (5 mm size):
- 6 A SB (230 V models)
- 16 A SB (100/115 V models)
(SB = slow blow)

1. Switch off the instrument
2. Remove the right and left rear panels from the instrument.
3. Locate the printed circuit board TT 3300-4-920 "Pump control":

4. Replace the fuse with the spare fuse. Switch on the instrument and check, whether or not the pump is working.

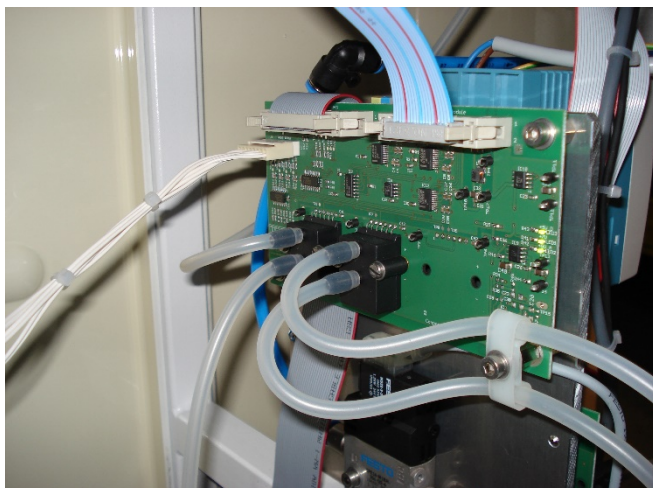
d) The printed circuit board TT 3300-4-930 Printed circuit board "Pressure sensors" needs replaced

In case one of the pressure sensors is defective, the pump will not start and the display shows 0.00. In this case, replace the pressure sensor pcb.
